Arborist Report on Copper Beech Tree

November 14, 2013

**Re: Tree assessment and protection plan for a copper beech located on the Butterfield Redevelopment site in Cold Spring, NY**

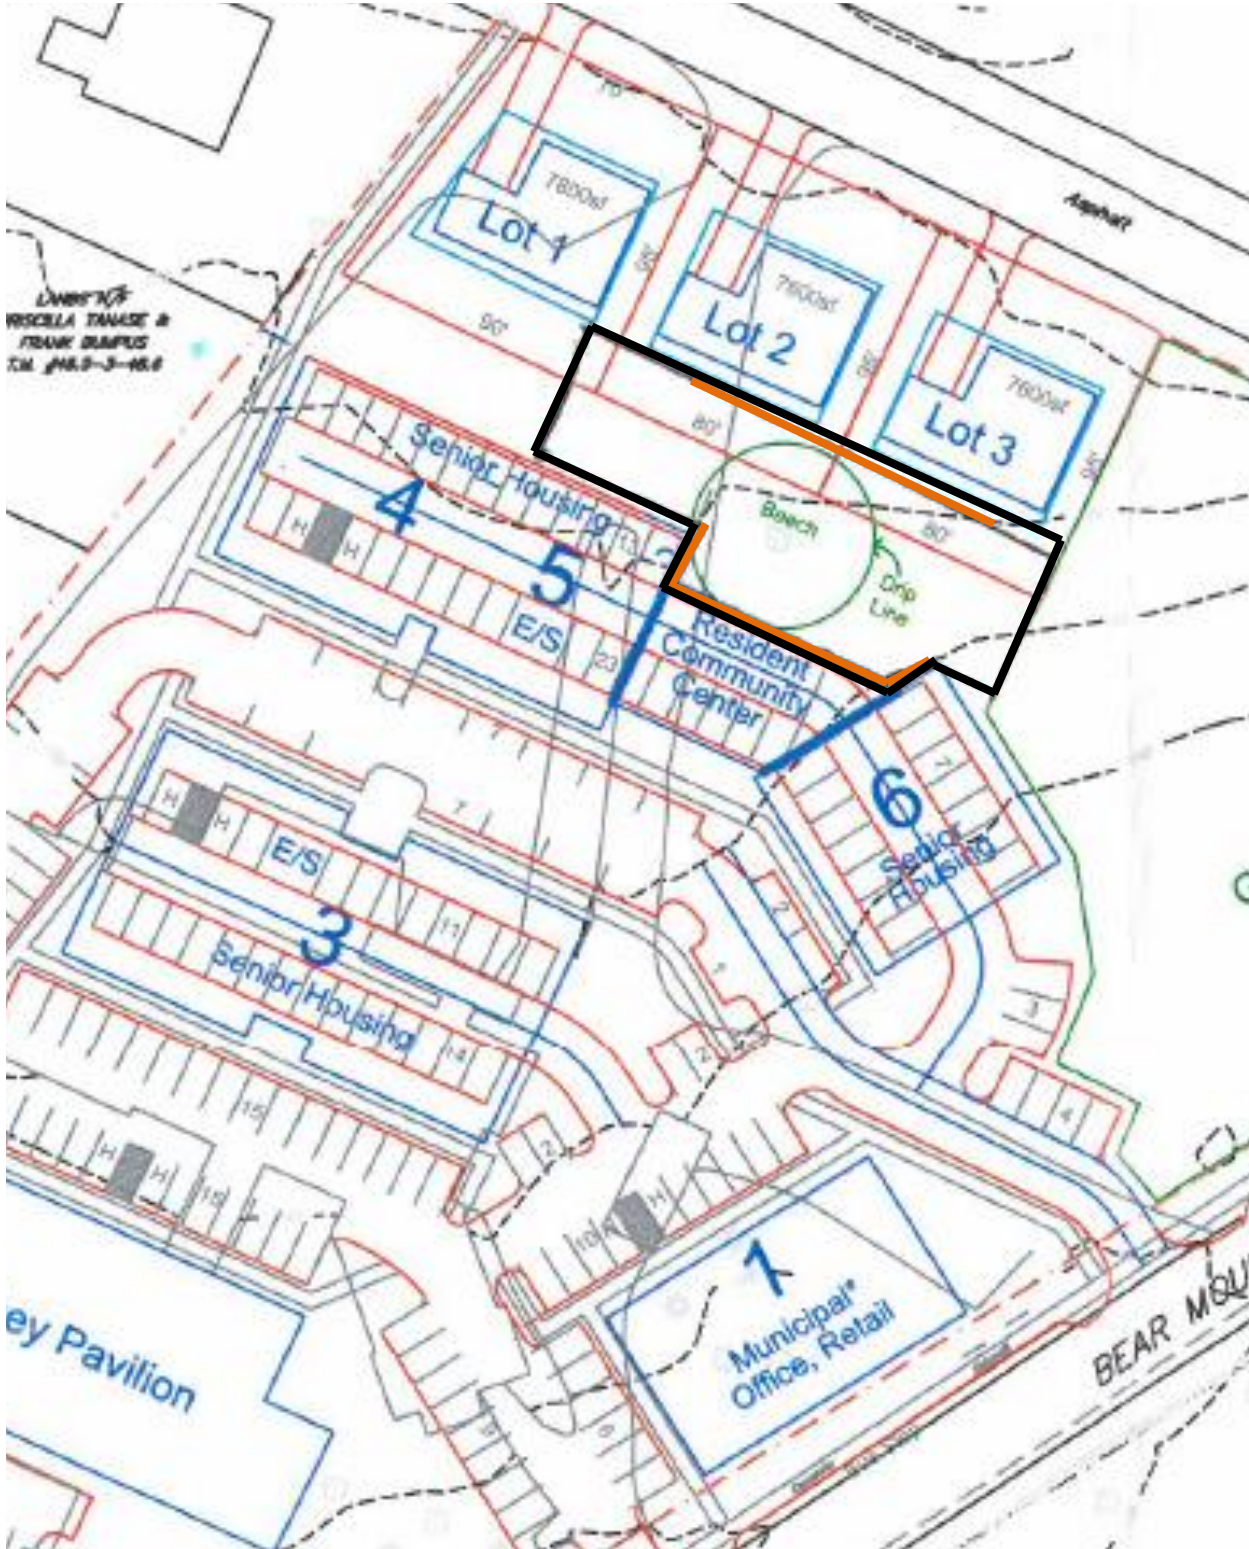
**Site Plan**

Edited site plan showing the areas that will require air excavation and root pruning (orange lines) and entire tree protection zone that extends 79.5 feet to the west and east of the tree (black outline).

- 1- Prior to any excavation, the limit of disturbance (LOD) adjacent to the tree should be excavated with an AirSpade®. Roots greater than 1" in diameter should be pruned by hand at the LOD by an ISA Certified Arborist. I included a marked up site plan at the end of this letter that shows the approximate locations in need of air excavation and root pruning.

- 2- A tree protection zone (TPZ) shall be established and enforced to prevent soil compaction, grade change, and root damage. I recommend 6' tall chain link fence be used to outline the TPZ. The approximate outline for the proposed TPZ is shown on the marked up site plan at the end of this letter.

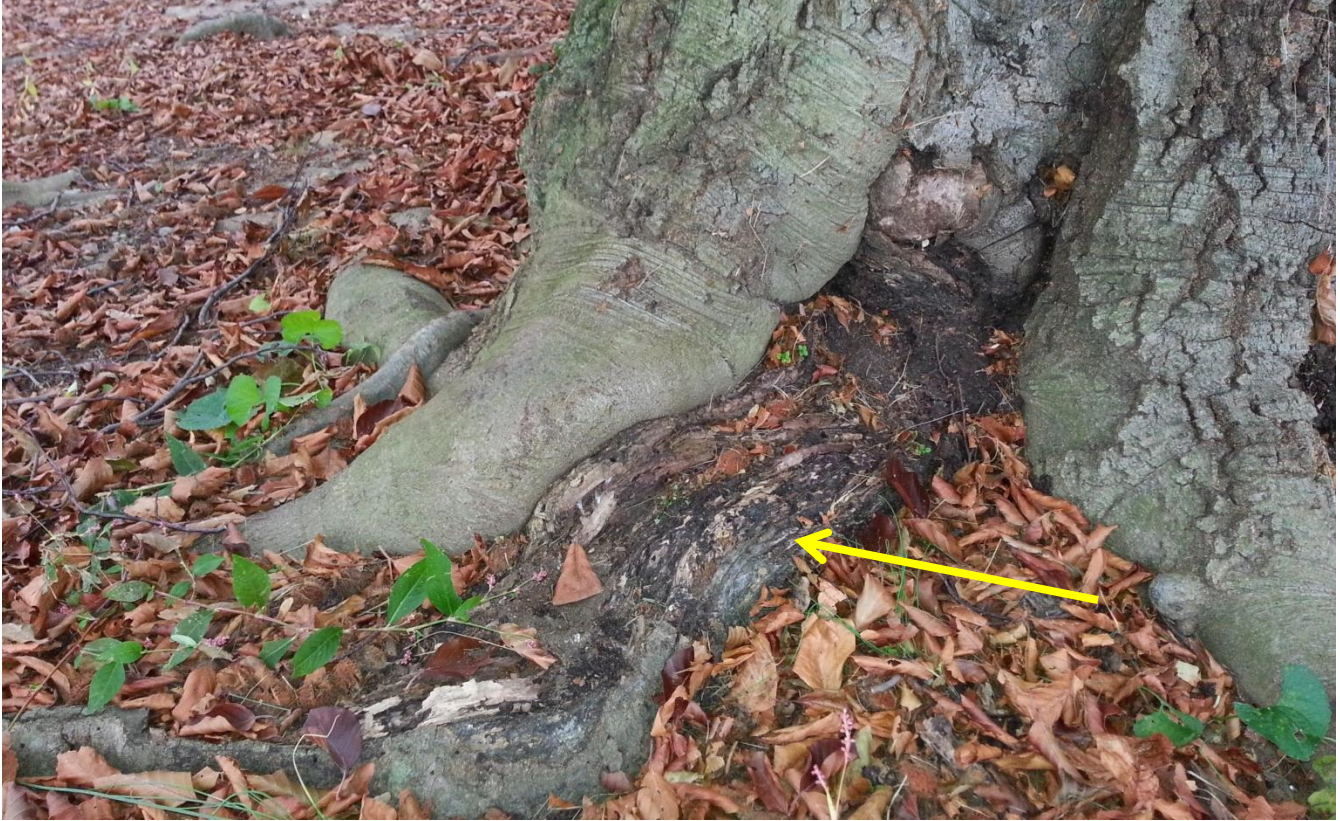
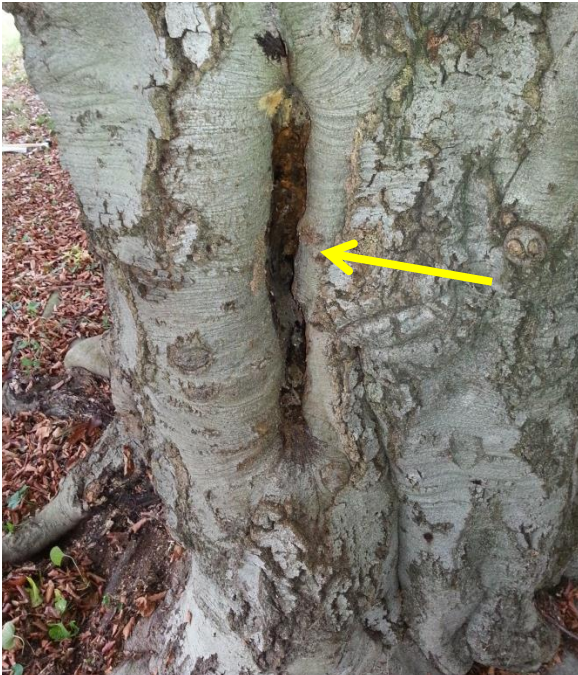
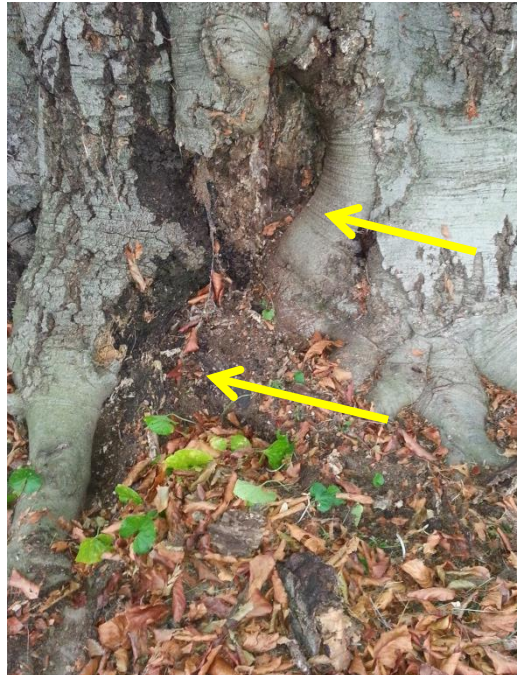
Taken 10/31/13, these photos show decay in two structural roots and the trunk of the tree. Sounding these areas with a mallet did not indicate significant internal decay. These defects are located on the western side of the tree.

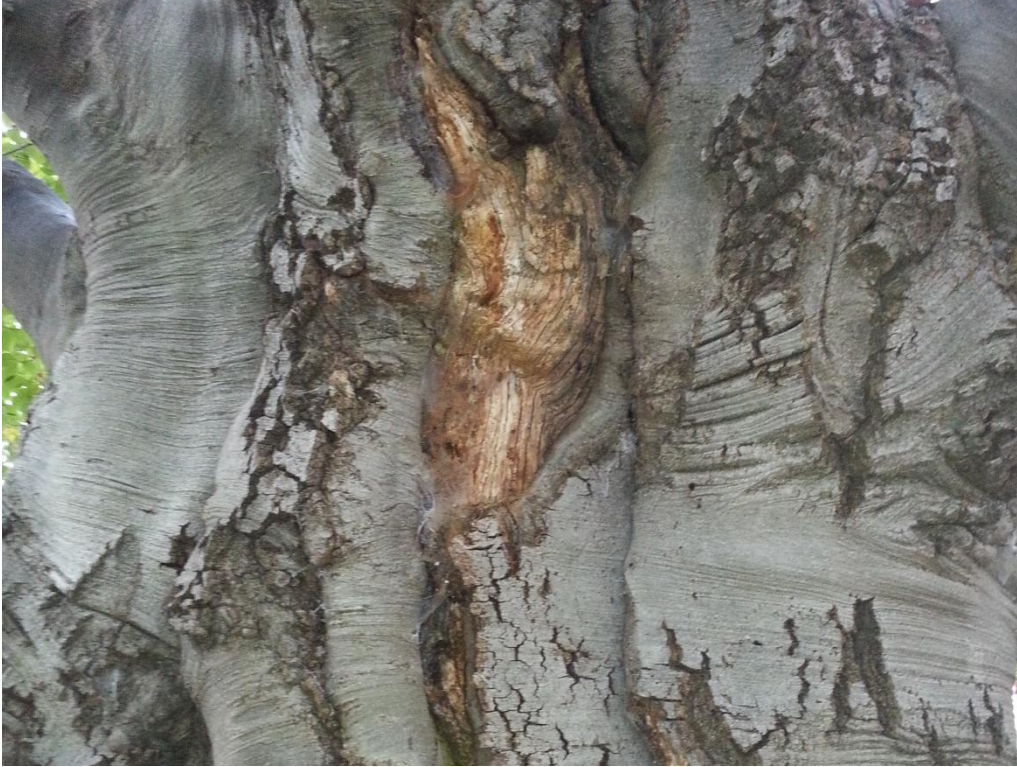
**Photo 4**

Area of external decay located approximately 6' from the base of the tree on the south side of the tree.

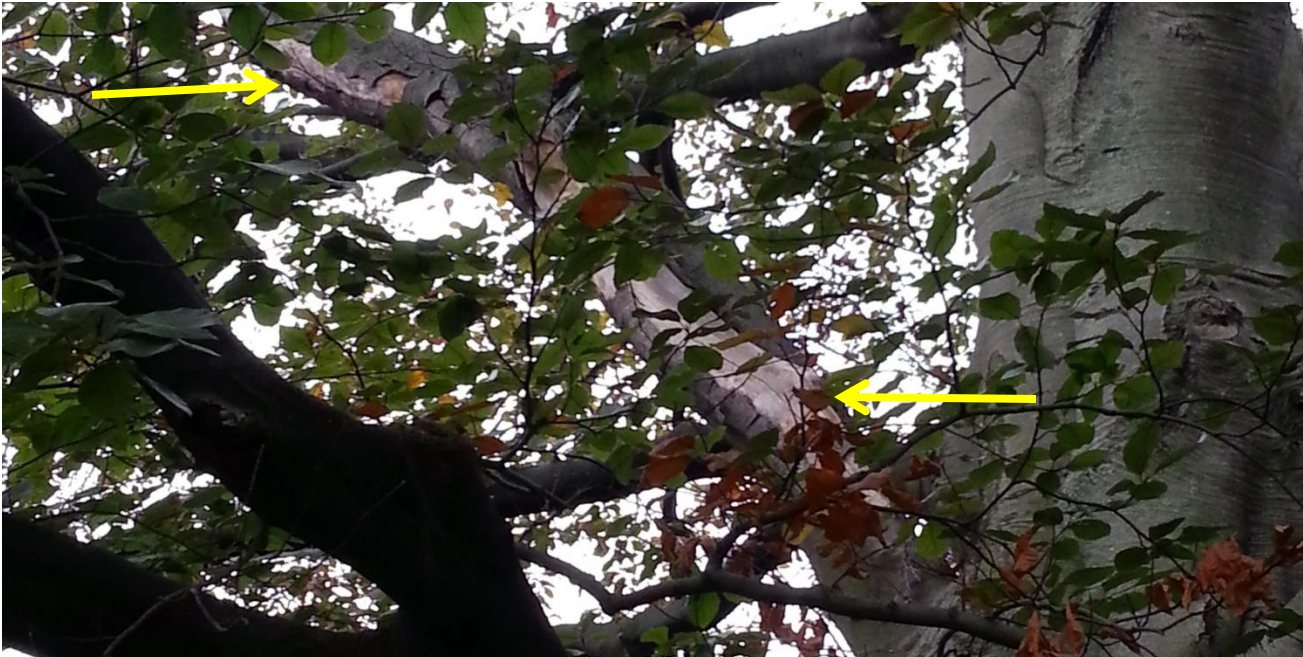
**Photo 5**

This tree is located in the vicinity of residential lot 2, senior housing building 5, and the resident community center on the site plan. I measured the distance from the base of the tree to corner of senior building 5 at 27.5 feet; to the corner of Lot 2 at 46 feet; and to senior building 6 at 61 feet. It is approximately 60' tall and is in good biological health. However, there is evidence of decay along the trunk and root zone (see Photos 1 through 4 at the end of this letter). There was one large limb in the canopy with dead, peeling bark (photo 5).

This photo shows the large, declining limb with peeling bark. This limb should be pruned out before the site is open to pedestrians.

- 5- The following pruning must occur prior to opening the site to the public:
  - a. Crown clean all deadwood 1" and greater for safety, including large limb shown in Photo 5.
