CAROL DRIVE BRIDGE -
STRUCTURE ASSESSMENT &
GRANT APPLICATION

Carol Drive Bridge
Structure Assessment

Prepared for: Town of East Fishkill
Date: September, 2013

Structure Number: 2262780 (NYSDOT Bridge Identification Number)
Route Carried: Carol Drive
Feature Crossed: Fishkill Creek
Roadway Classification: Local Road
Design/Posted Speed: 30 mph
AADT (current/year): 699/2008 (from 2011 NYSDOT Biennial Inspection)
Inventory Rating HS: HS 19.8 (as-designed)
HS 13.2 (as-built)

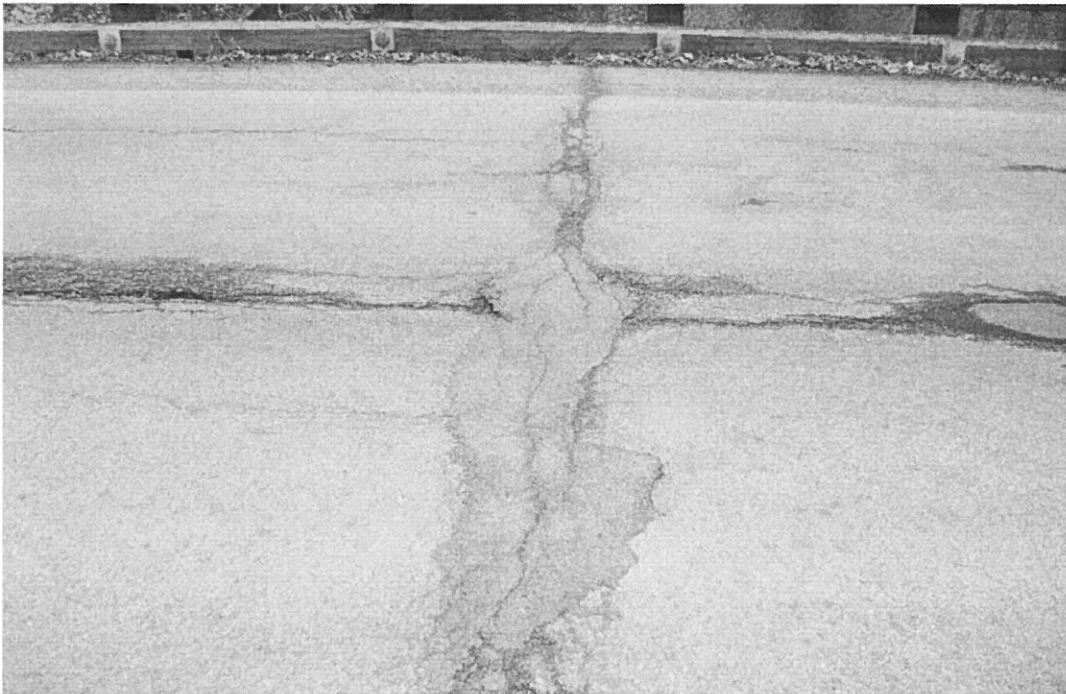
The asphalt wearing surface displays reflective cracking at all four joint locations, and several other areas of distress. The wearing course has been patched above the joints.

Photo 2: Crack in Asphalt at Pier

Replace the waterproofing membrane and asphalt wearing surface, and examine the condition of the joints. Field observations indicate that the steel plates above the transverse joints may be failing; these plates should be examined and potentially replaced. Arresting water infiltration to the superstructure could extend the life of the deck spans an additional 25 years or more, assuming the timbers are currently unaffected by decay.

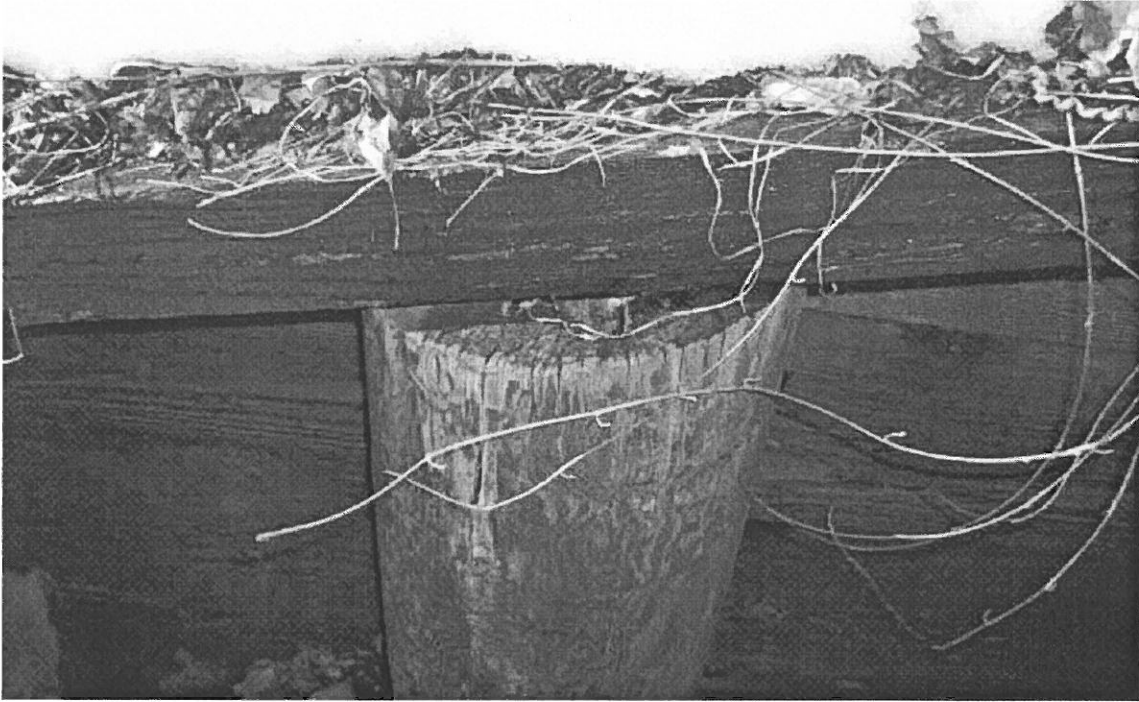
The timber pile and lagging abutments are in fair condition. There is scour visible at the abutment stem, and rot is evident in the west abutment right wingwall piles above the tieback elevation.

Photo 5: SW Wingwall Pile with rot at top

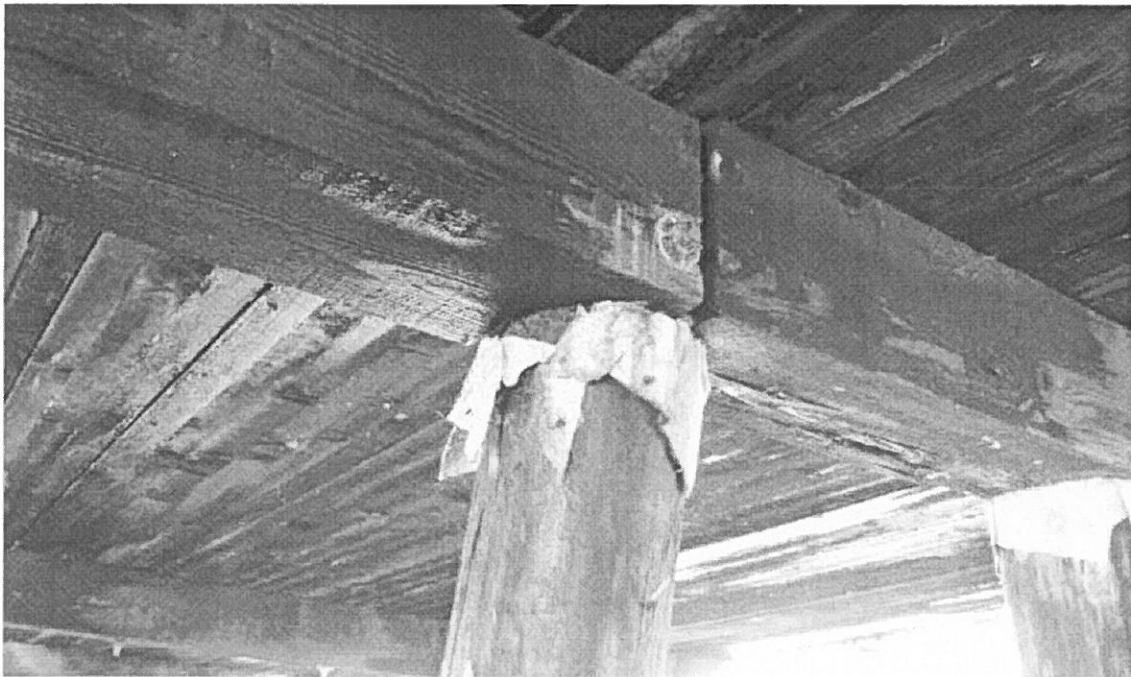
The cap beams are stained by water infiltration. A lap joint in the 12x12 timber cap beam results in an as-built load rating of HS13.2. This lap joint is not included in the original design calculations or on the plans; the plans specify a continuous 12x12 timber member.

In addition to vulnerable nature of the timber construction, the joint in the cap beam at the west abutment and at pier 1 represent an as-built defect that affects the load carrying capacity of the bridge. This joint can be retrofitted to support the design load, but until that occurs, the loads on the structure should be limited as discussed in Section VI, Recommendations.

Photo 6: Pier 1 Cap Beam Splice

1. The lap joints in the cap beam are remediated. An engineered retrofit of this condition is required so that the cap beams can perform as-designed.
2. Pile decay is investigated and remediated if it is present. In situ repair of decayed timber piles has been done on several demonstration projects, with results published by the FHWA and the American Society of Civil Engineers. The methods utilize differing construction techniques, from epoxy and glass fiber wraps to concrete encasement. An engineered solution at the Carol Drive Bridge would be needed.

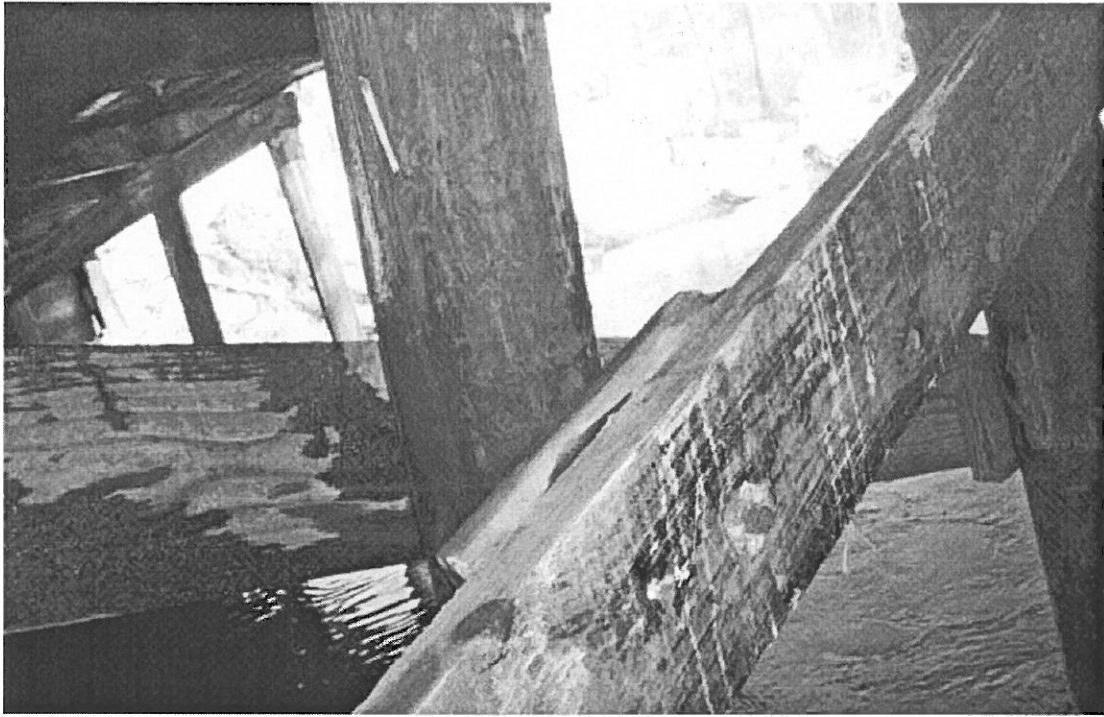
The piles are unremarkable. The lateral bracing is functioning as designed. All of the piles were installed in a nearly vertical orientation, however the plans specify a 1 on 12 batter of the outboard piles. The absence of this batter leads to increased stress on the lateral bracing.

The piles are vulnerable to impact by debris during storm events. Large floating objects can deliver a severe blow to unarmored pile bents. Further, the absence of battered piles will cause a higher stress on the lateral pile bracing. The bolted connection of the lateral bracing to the piles is also a concern, as several of these connections occur in areas near the waterline where decay is more likely to be present.

Photo 7: Wood Pile Pier Cross Bracing

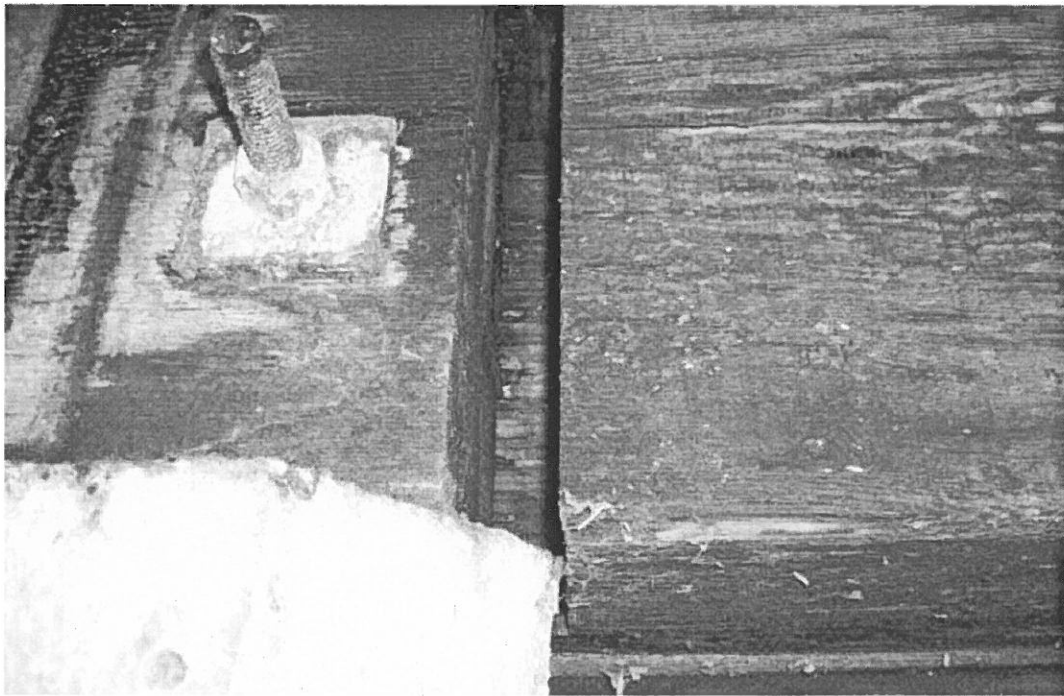
Photo 8: West Abutment Cap Beam Splice off Pile

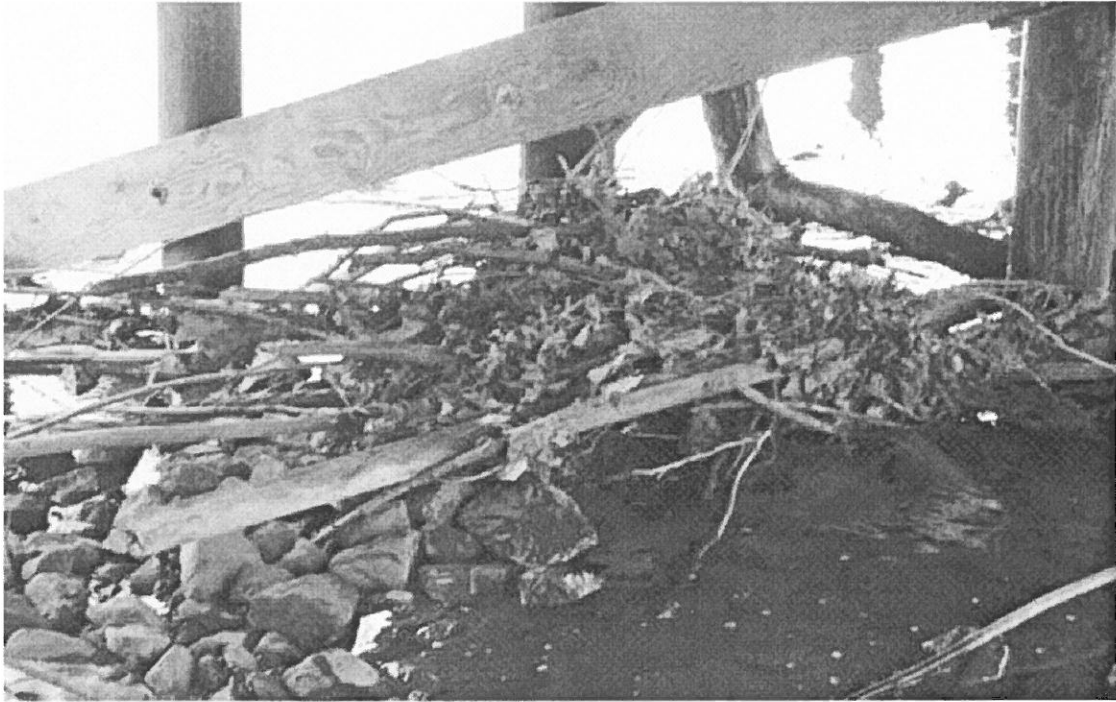
Photo 10: Debris in steam under bridge between West Abutment and Pier 1

The piers are vulnerable to collision with debris or large floating objects during periods of high flow or storm events. Installation of a debris deflector or similar pier protection would mitigate this risk. An appropriate installation would be a V shaped array of piles where the V is pointed upstream and is therefore able to shed debris away from the bridge pier.

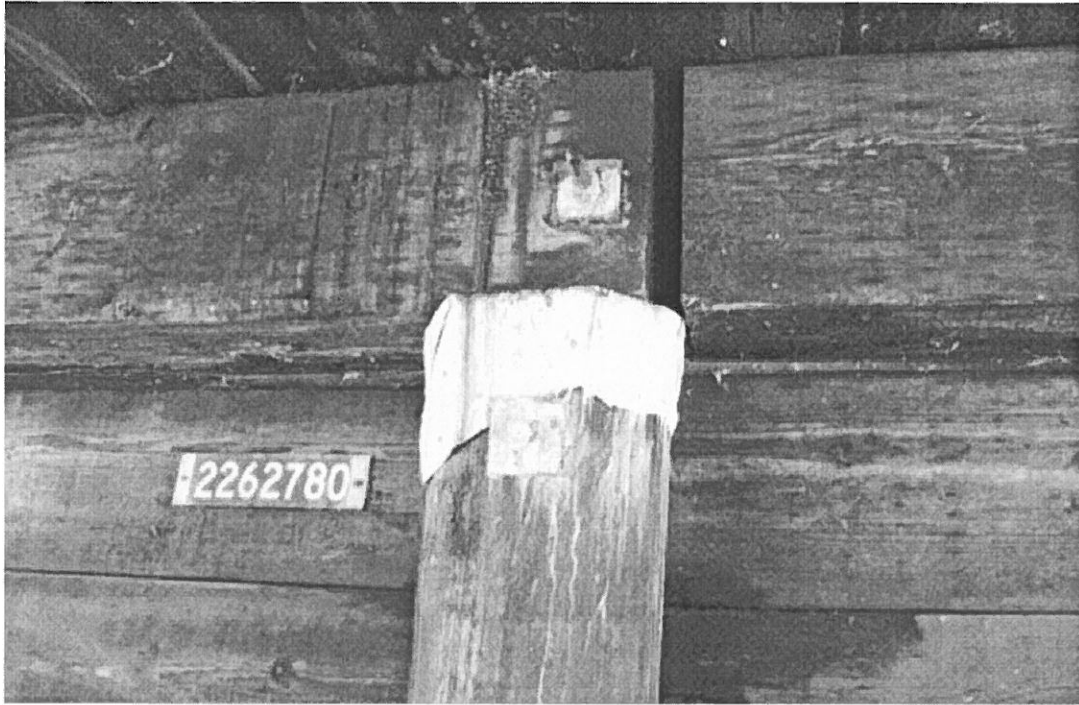
Photo 11: West Abutment Cap Beam Splice off Pile

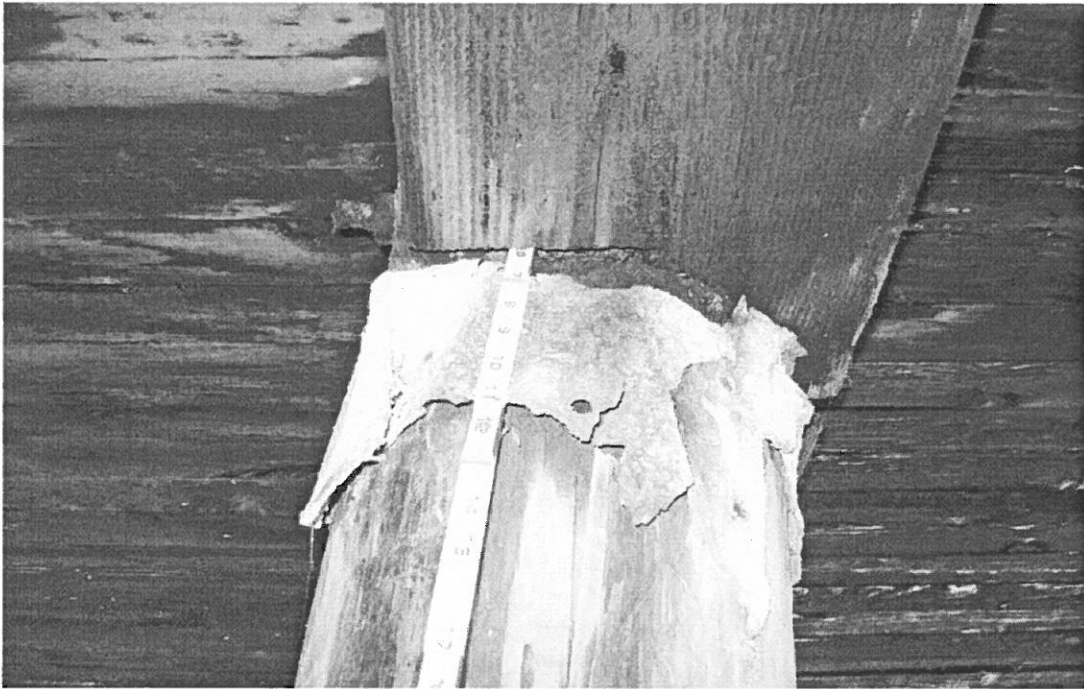
Photo 12: Looking up at Pier 1 Cap Beam, CL of Splice off Pile

Due to Notch in cap beam at cap beam splice location and CL of splice not located on pile take shear at reduced cross section of notch.

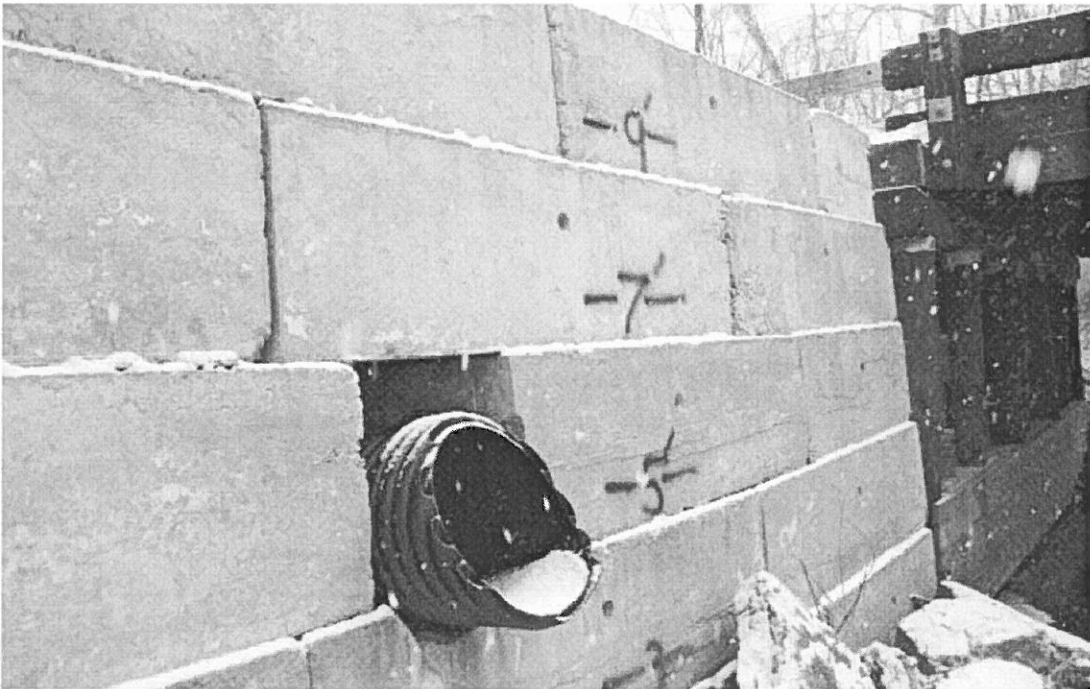
The bridge is also hydraulically vulnerable. Scour has necessitated remedial work at one abutment, where a concrete scour curb was poured in front of the stem, and a concrete block extension was installed to lengthen one of the wingwalls. The stream banks feature many trees with exposed roots, indicating a widening of the stream bed. This transformation could eventually challenge the stability of the abutments, although the banks do not appear to be in immediate jeopardy near the bridge.

Photo 14: NE Wing wall constructed from Concrete "Mafia" Blocks

The bridge is vulnerable to scour at the abutments. Scour has been remediated at the east abutment through addition of a scour apron, and the original bank protection at the west abutment is functioning as designed. Still, widening of the stream channel continues to occur, and the scour protection at the bridge is limited to light stone fill. Medium stone ($D_{50} > 12"$) would be better suited for this purpose.
