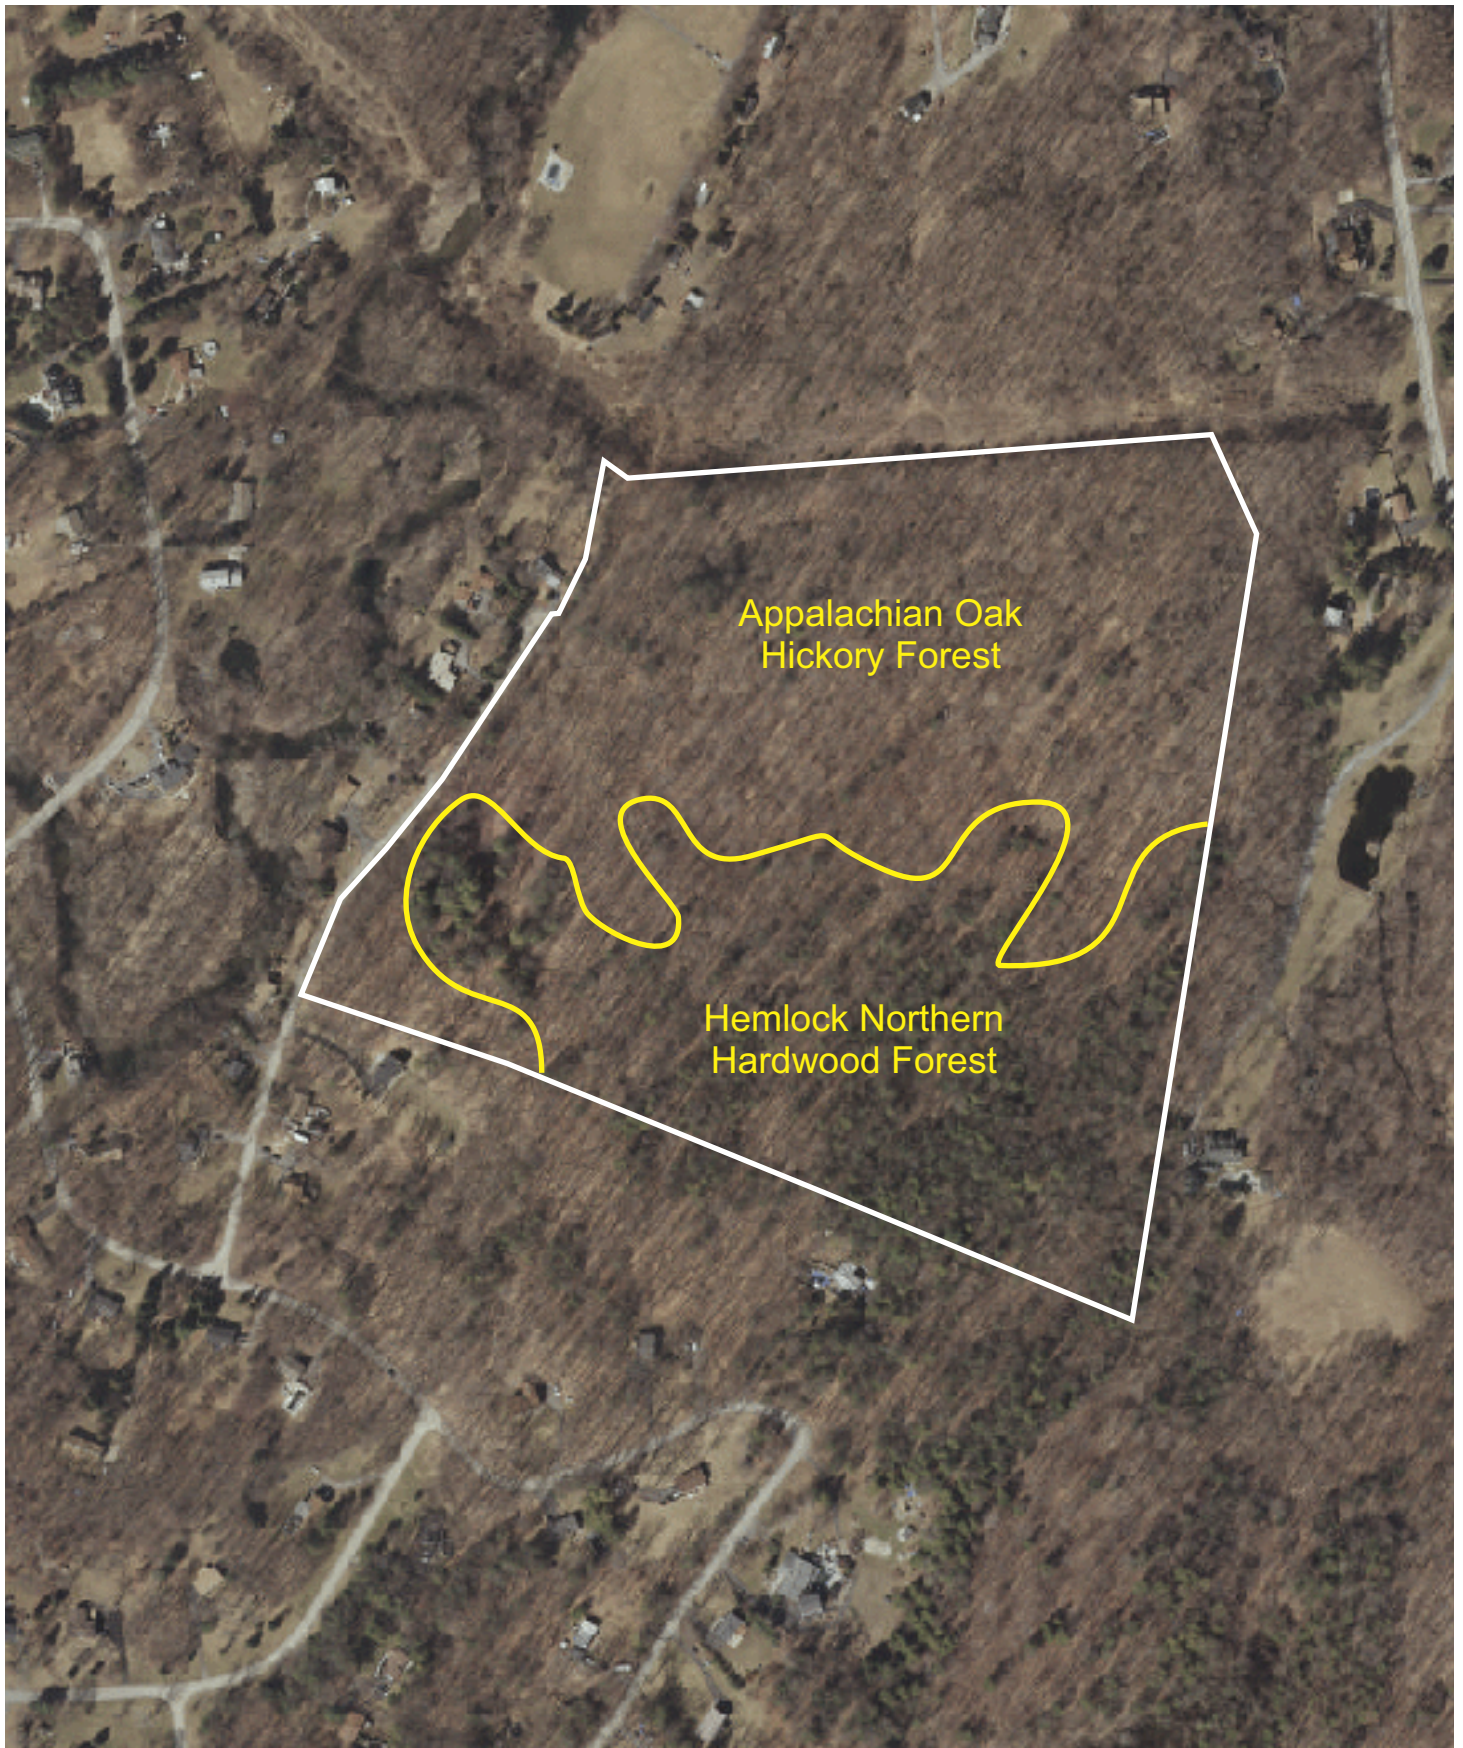
Figure E.1-1: Vegetative Cover Types
Hilltop Manor Subdivision
Town of East Fishkill, Dutchess County, New York
Aerial Photo Source: Dutchess County GIS, 2009 photo

No rare, threatened, or endangered plant species or significant habitats or plant communities were identified on the site. There are only two distinct cover types identified on the site. These cover types are outlined in Table E.1-1 and (*Figure E.1-1, Vegetative Cover Types*).

Southern Portion of Property – As shown in Figure E.1-1, this habitat is generally a mixed forest that occurs on middle and lower slopes of ravines, on cool, mid-elevation slopes, and on moist, well-drained sites at the margins of wetlands. Eastern hemlock (*Tsuga canadensis*) is co-dominant with any one to three of the following: beech (*Fagus grandifolia*), sugar maple (*Acer saccharum*), red maple (*Acer rubrum*), black cherry (*Prunus serotina*), white pine (*Pinus strobus*), yellow birch (*Betula alleghaniensis*), black birch (*Betula lenta*), red oak (*Quercus rubra*), and basswood (*Tilia*

americana). The relative cover of hemlock is quite variable, ranging from nearly pure stands in some steep ravines to as little as 20% of the canopy cover. These trees are generally of the same age class 5-12-inch dbh with some trees being slightly larger in the 20 – 24 inch dbh range. On the Hilltop Manor site, this community dominates the southern portion of the site as shown on Figure E.1-1

Remaining Portion of Property (Northern ridge and east and west facing slopes) – As Figure E.1-1 shows, this hardwood forest occurs on well-drained portions of the parcels generally on the ridgetops, upper slopes, or east- and west-facing slopes. The soils are shallow loams or sandy loams. The dominant trees include one or more of the following oaks: red oak (*Quercus rubra*), white oak (*Quercus alba*), or black oak (*Quercus velutina*). Mixed with the oaks, usually at lower densities, are one or more of the following hickories: pignut (*Carya glabra*) and shagbark (*Carya ovata*). Common associates are white ash (*Fraxinus americana*), red maple (*Acer rubrum*), and Eastern hop hornbeam (*Ostrya virginiana*). The trees are generally in same age class with small-young trees in the 4-6 inch dbh range with only a few individuals in the 20 – 24 inch bh range. The subcanopy stratum contains small trees and tall shrubs including flowering dogwood (*Cornus florida*), witch hazel (*Hamamelis virginiana*), and shadbush (*Amelanchier arborea*). Common low shrubs include maple-leaf viburnum (*Viburnum acerifolium*), blueberries (*Vaccinium angustifolium*), red raspberry (*Rubus idaeus*), and gray dogwood (*Cornus racemosa*). The shrub layer and groundlayer flora are more diverse. Characteristic groundlayer herbs are false Solomon's seal (*Smilacina racemosa*), Pennsylvania sedge (*Carex pennsylvanica*), tick-trefoil (*Desmodium glutinosum*, *D. paniculatum*), rattlesnake root (*Prenanthes alba*), white goldenrod (*Solidago bicolor*), and hepatica (*Hepatica americana*).

As shown in Table E.2-1 - Existing and Proposed Vegetation, the proposed project would cause the removal of existing vegetation for site grading, roads, and construction of new dwellings on approximately 28.75 acres (70% of the project area). As shown in Figure E.1-1 *Vegetative Cover Map*, grading of the site, construction of the roads, and development of dwellings will result in the removal of approximately 28.75 acres of forest. Loss of vegetation and wildlife habitat is the unavoidable result of the removal of topsoil and vegetative cover and replacement of by impervious surfaces. Natural areas will be replaced with urban habitat types, such as mowed lawn with trees, paved road, and other impervious surfaces.

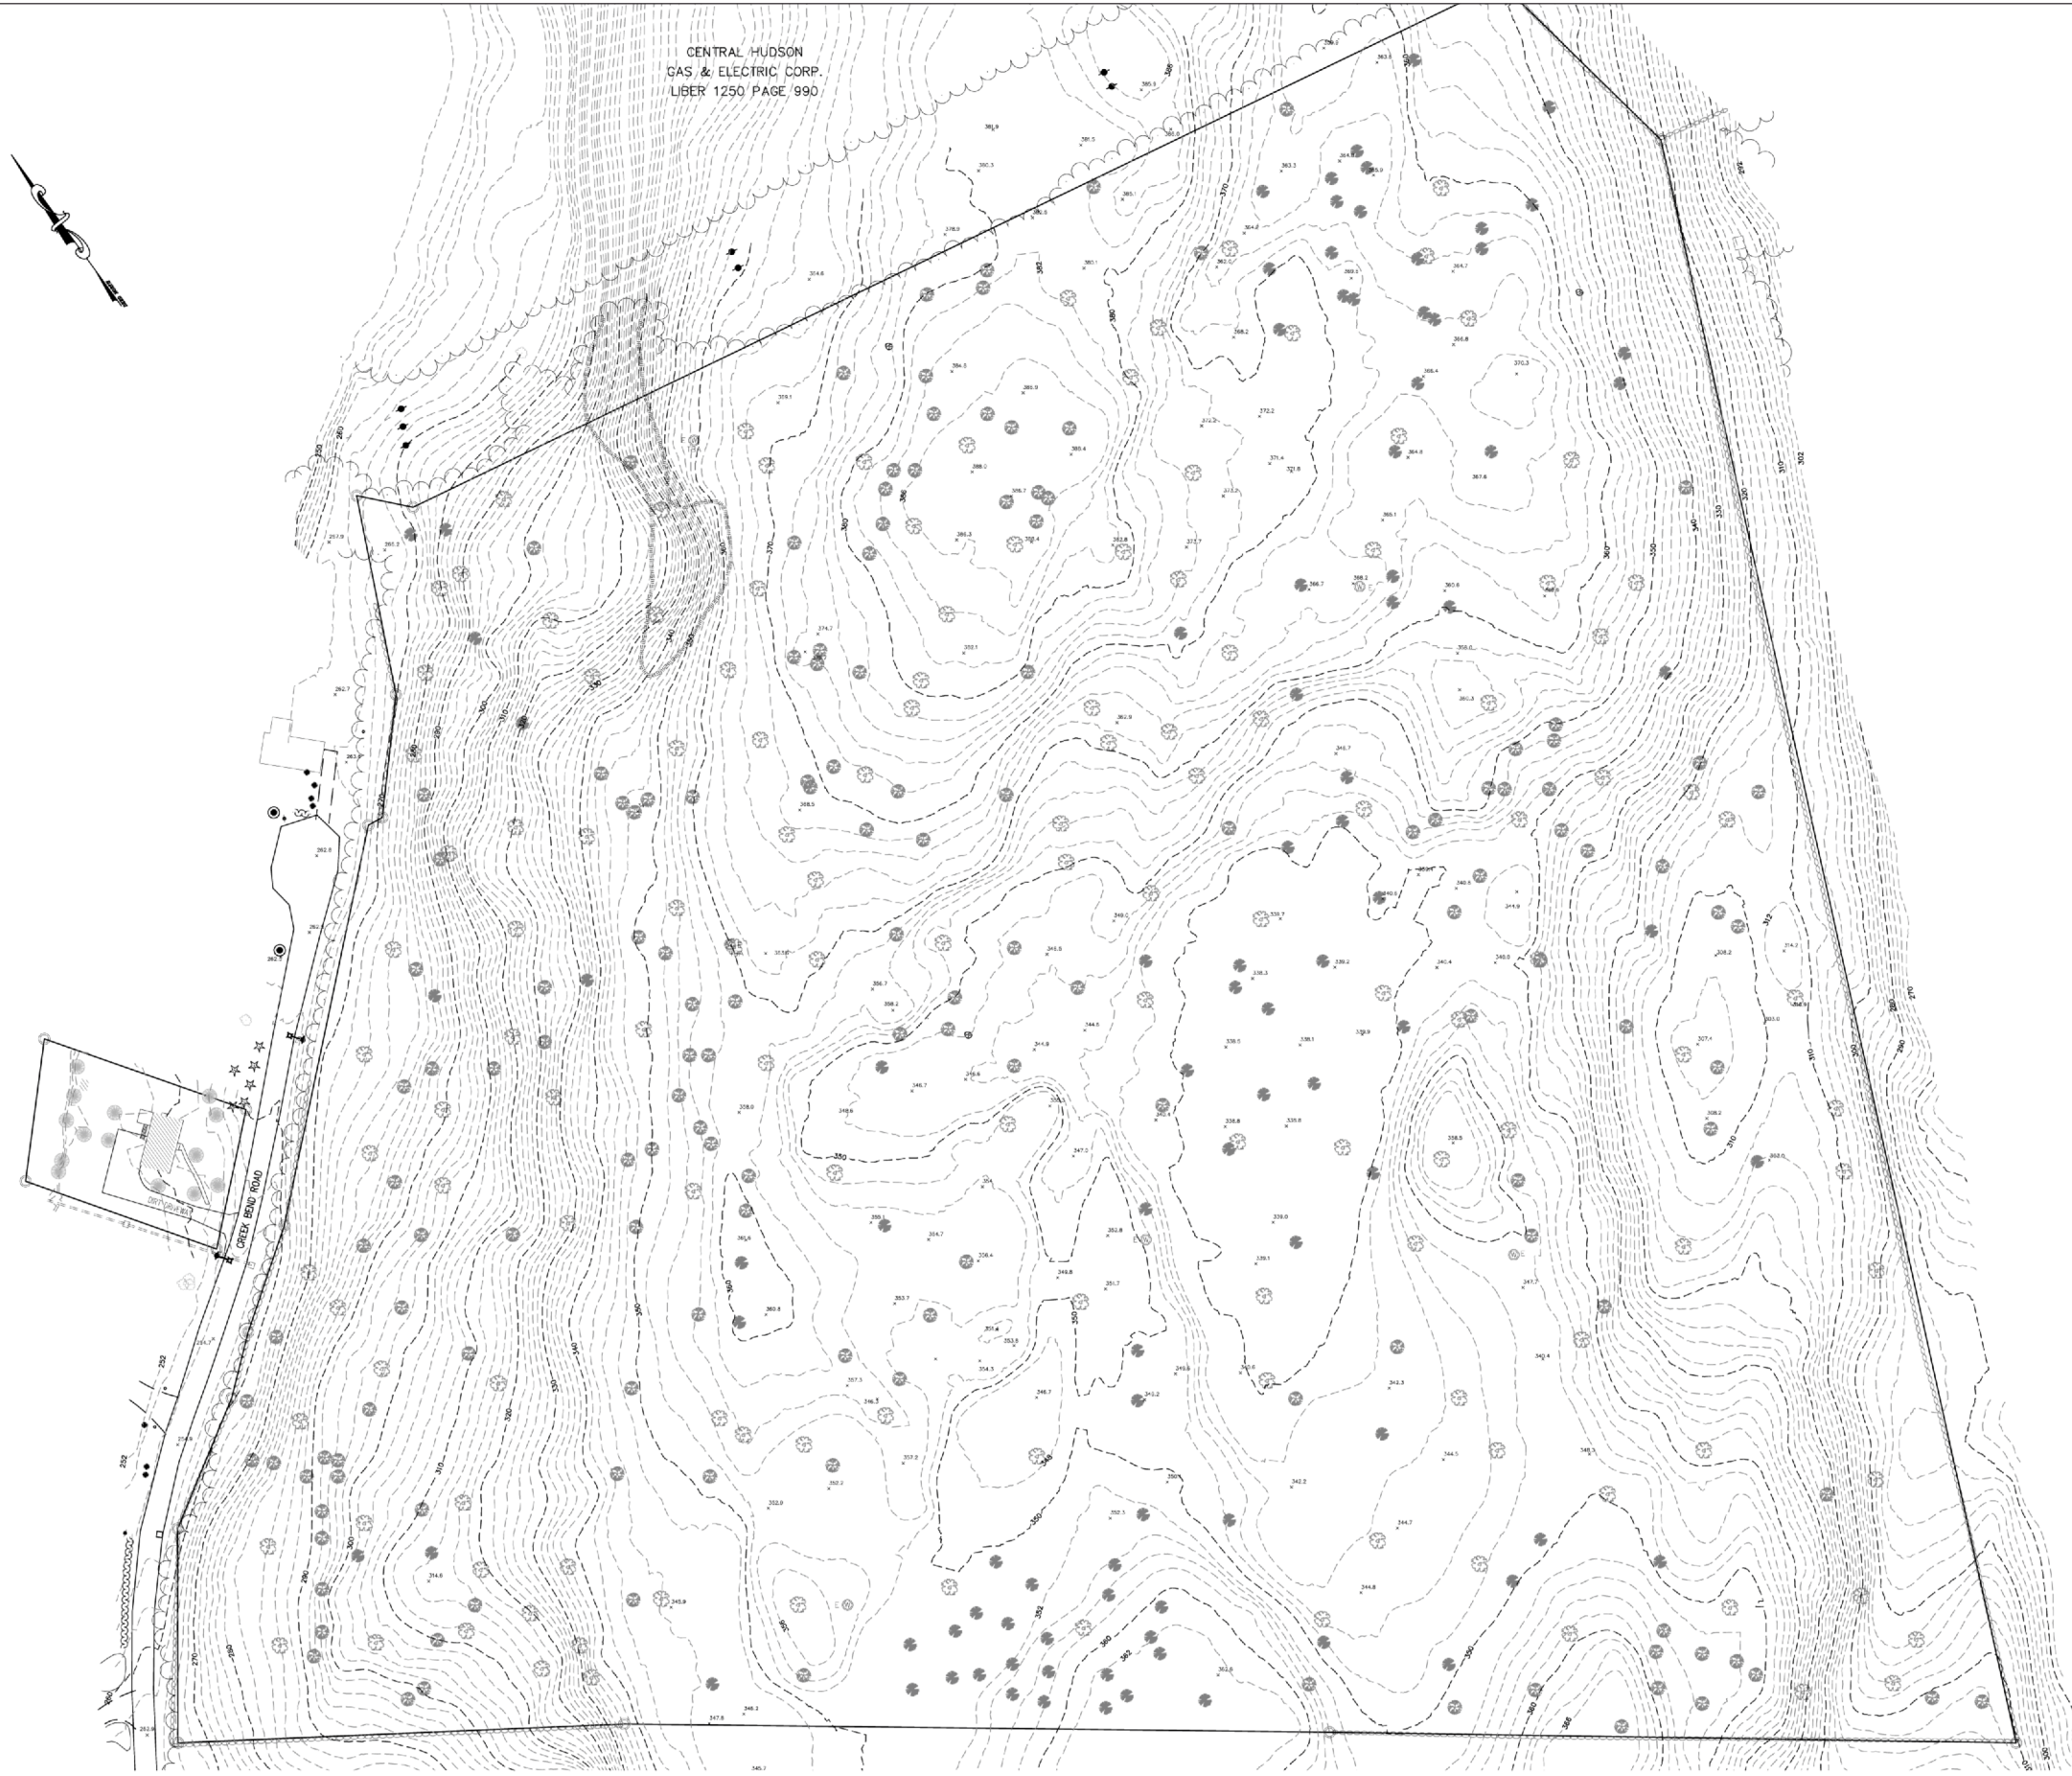
Figure E.1-2: Tree Survey
 Hilltop Manor Residential Subdivision
 Town of East Fishkill, Dutchess County, New York
 Source: M. Gillespie & Associates Consulting Engineers, PLLC.
 NTS

The vegetation inventory included identification of ecological communities or habitat cover types. Cover type surveys were conducted by first reviewing aerial photographs of the parcels and adjacent parcels and subsequently by investigating the habitats on the site to identify and classify each. A tree survey was completed on the site by Robert Oswald, PLS and identified approximately 285 trees 12 inches diameter at breast height and larger (*Figure E.1-2 Tree Survey*). About 120 of these larger trees, or 42 percent, will be removed for development activities.
