3.9 Visual Resources

3.9.1 Existing Conditions

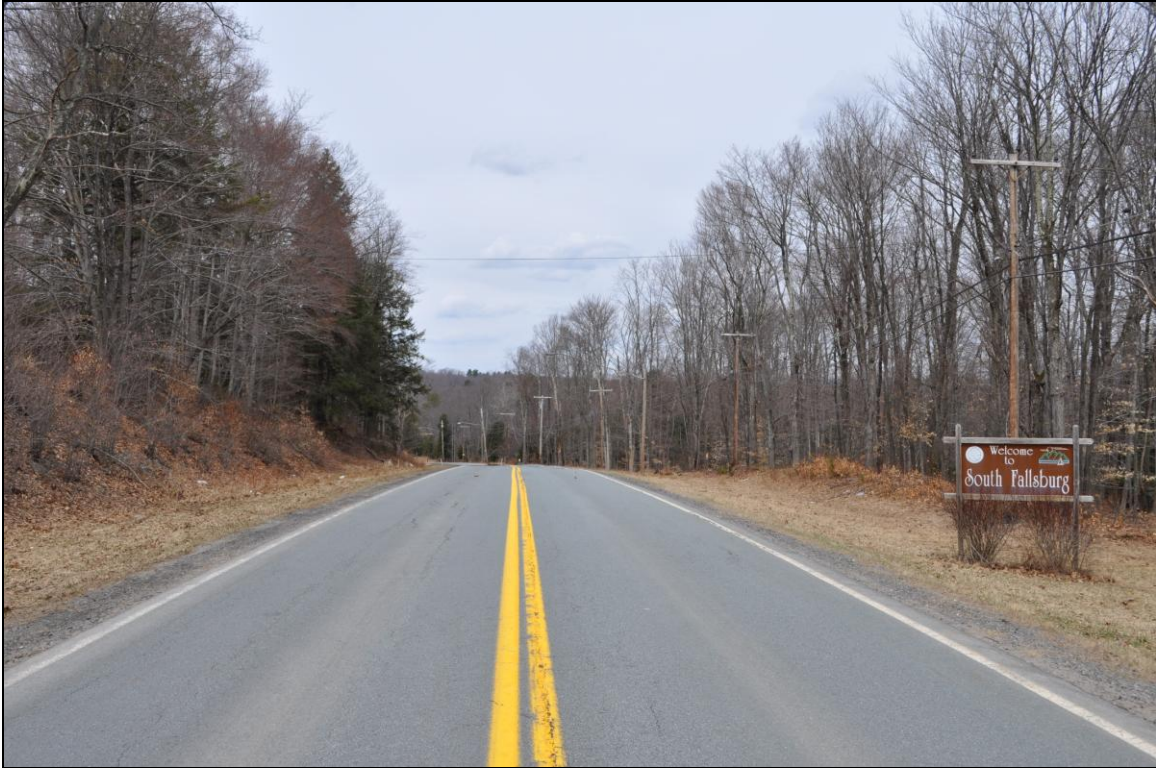
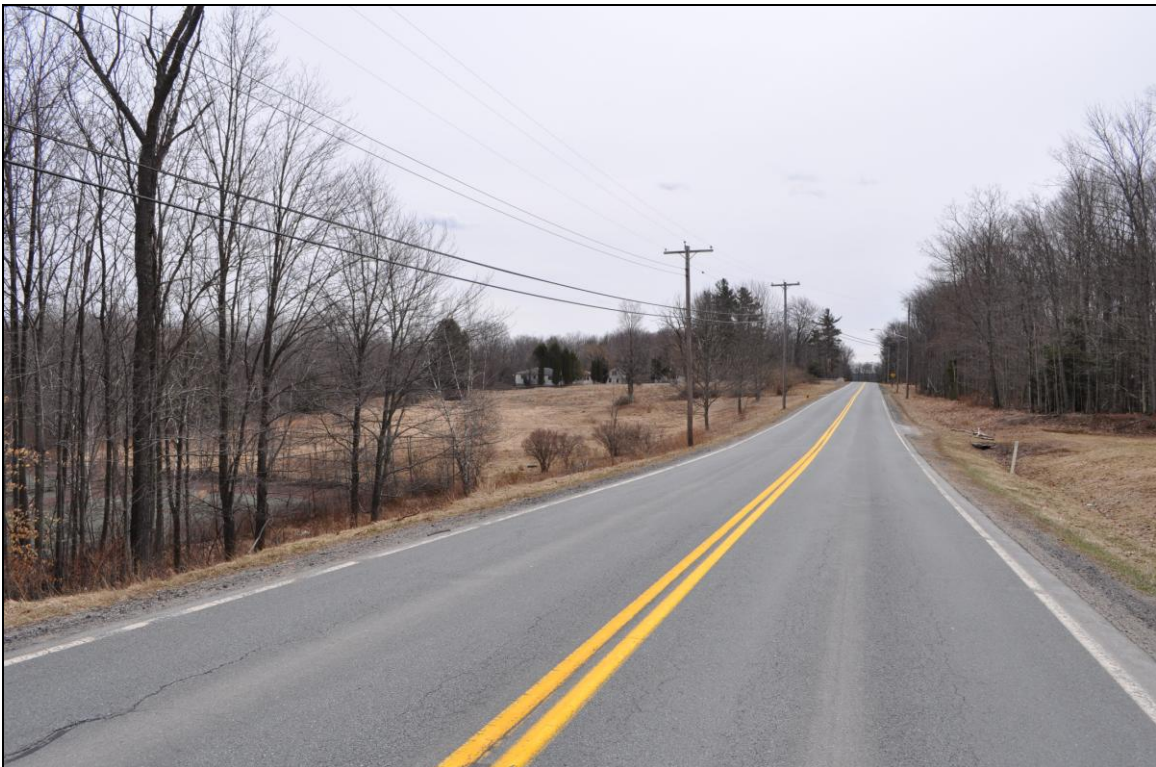
Figure 3.9-2: View Point 1 - Looking North on Heiden Road

Figure 3.9-2: View Point 1 - Looking South on Heiden Road

As previously noted, the greatest visual exposure of the project site under current conditions is from Heiden Road at the northwest corner of the property (identified as Viewpoint 1) where the viewer is situated above the elevation of the property. The sloping open meadow allows a view extending 300 to 400 feet into the property to the tree line. This view is experienced by travelers on Heiden Road for a brief period while passing the site. Figure 3.9-1 shows the existing views looking north and south from the high point in Heiden Road, respectively.
